David Montgomery, President  
Coastal Energy Corporation  
P.O. Box 218  
Willow Springs, Missouri 65793

### NOTICE OF VIOLATION

**REPORT OF COMPLIANCE INSPECTION  
COASTAL ENERGY CORPORATION  
HOWELL COUNTY  
MO0136883  
NOVEMBER 7, 2014**

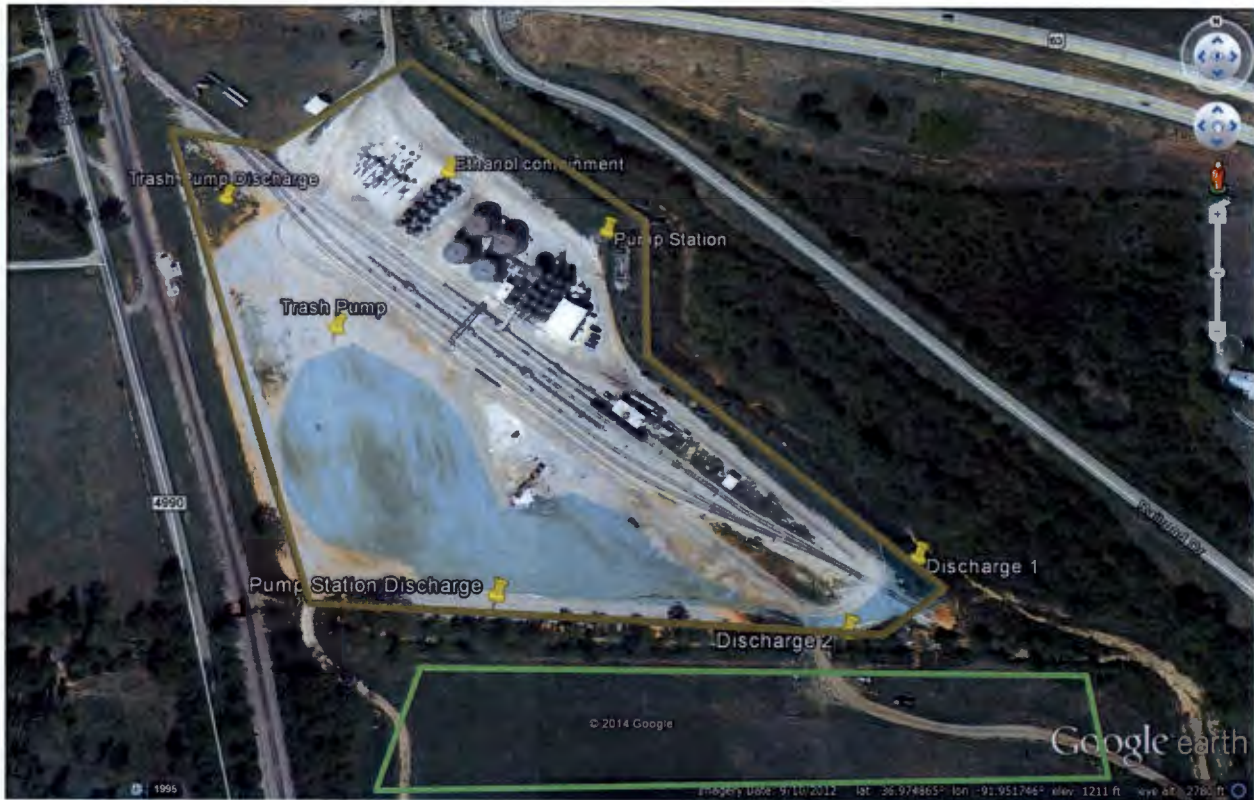
As you can see from the following image captured from Google Earth, the Coastal Energy Corporation permitted area consists of a tank farm and rail spur that stores and handles asphalt and ethanol. The tank farm and rail spur area is surrounded by an earthen berm, the approximate location of which is noted by a brown line in the image. Within the bermed area there is also a great deal of space southwest of the rail spur that is currently being used to store stormwater.

Stormwater collected within the bermed area is permitted to be land applied on a 28 acre vegetated area adjacent to the bermed area. Land application is intended to be conducted with a truck. The approximate location of the land application area is outlined in green on the image, although not all of the land application area is visible due to the scale of the image. More land application area exists to the south.

At the time of my inspection, stormwater had accumulated within the bermed area and was flooding an area approximated by the blue shading in the image below.

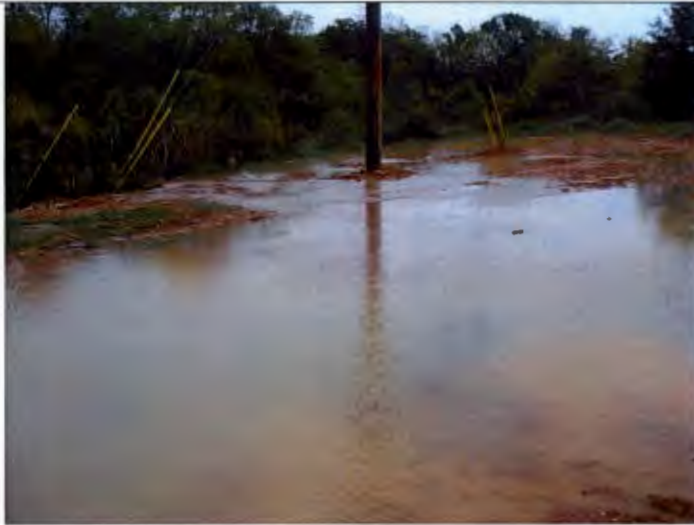
During the inspection, I observed stormwater overflowing the facility's earthen berm at the southeast end of the bermed area. Stormwater on the northeast side of the rail spur was discharging into the Eleven Point River. Stormwater on the southwest side of the rail spur was discharging into an unnamed tributary to the Eleven Point River. Discharges from the bermed area would be considered a discharge from outfall #002.

**Photo:** 001  
**By:** Arthur Goodin  
**Facility:** Coastal Energy Corporation  
**Permit:** MO0136883  
**Location:** Howell County  
**Description:** Water discharging over the facility's earthen berm at the *Discharge 1* location, near the southeastern corner of the property.  
**Date:** 10/10/2014  
**Program:** WPC Unit

**Required Actions:** Coastal Energy Corporation must, within fifteen (15) calendar days of receipt of this report, reply in writing what they believe to be the cause of this violation and what steps they are going to take to prevent the violation from reoccurring.

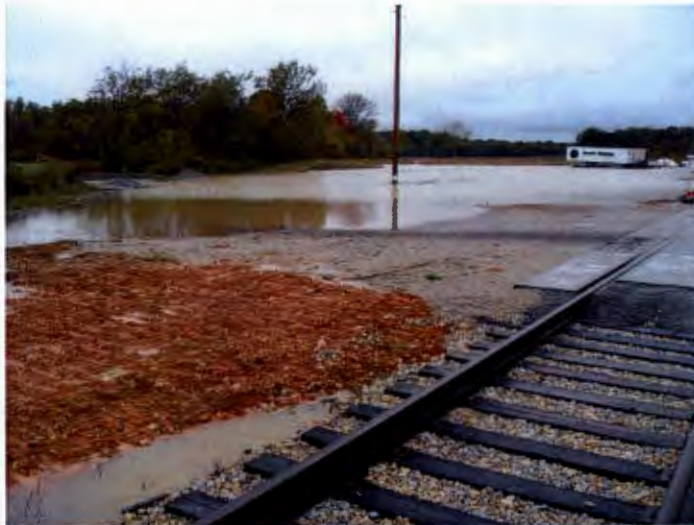
**Photo:** 002  
**By:** Arthur Goodin  
**Facility:** Coastal Energy Corporation  
**Permit:** MO0136883  
**Location:** Howell County  
**Description:** View looking northwest from the end of the rail spur. Note the flooding inside the bermed area.  
**Date:** 10/10/2014  
**Program:** WPC Unit

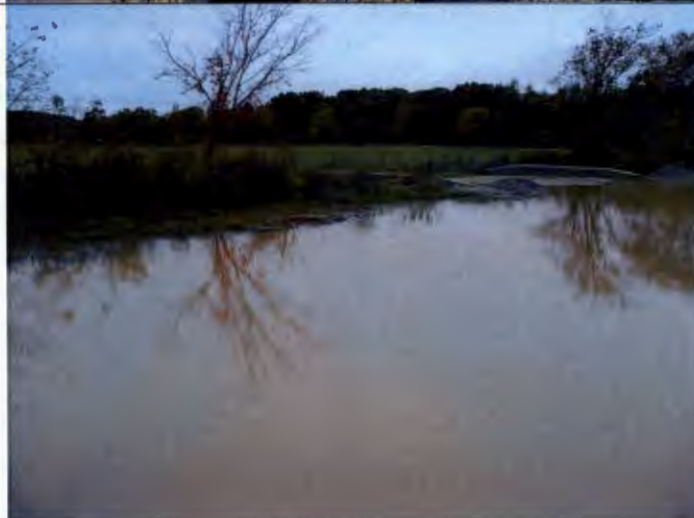
**Photo:** 003  
**By:** Arthur Goodin  
**Facility:** Coastal Energy Corporation  
**Permit:** MO0136883  
**Location:** Howell County  
**Description:** Water discharging over the facility's earthen berm at the *Discharge 2* location, near the southeastern corner of the property.  
**Date:** 10/10/2014  
**Program:** WPC Unit

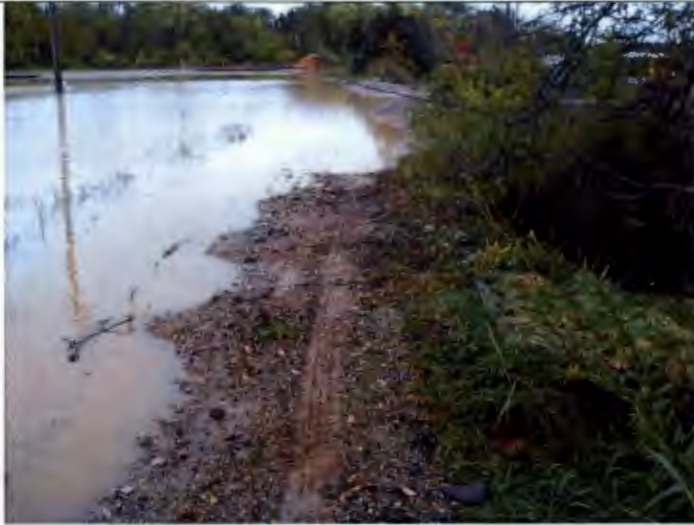
**Photo:** 004

**Description:** Water at the top of the facility's earthen berm. Photograph taken on the berm at the southern edge of the facility, facing east.

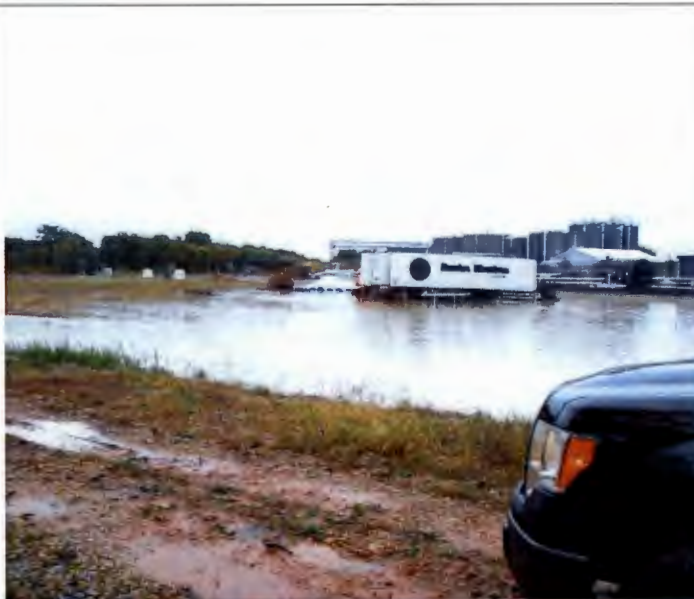
**Photo:** 005

**Description:** View of flooding inside the bermed area. Taken at the same location as photo 004 but facing north.

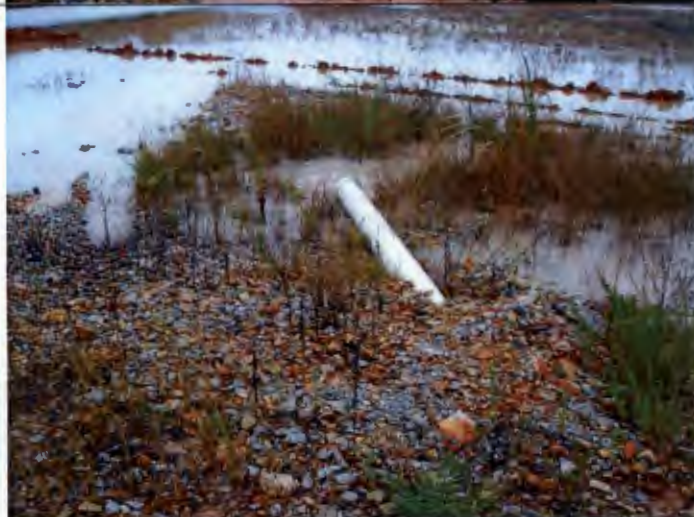
**Photo:** 006

We then traveled to the bermed area's main pump station, which Coastal had labeled as Outfall #002 with a sign. This pump station, which was actively pumping during my inspection, was pumping stormwater from the area northeast of the tank farm and rail spur to the southwest side of the bermed area.

**Description:** Water discharging into the southern half of the bermed area. This water is being pumped from the main pump station labeled Outfall #002.

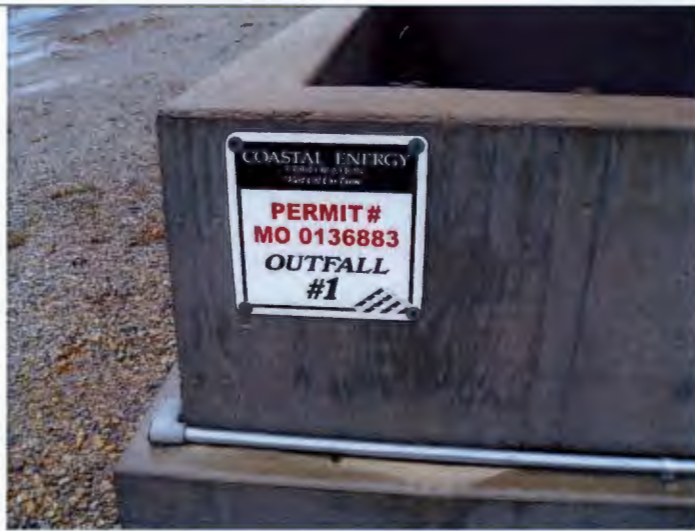
Mr. Marty Malkowski escorted me to the tank farm area. The purpose and scope of the inspection were outlined. We began the inspection by driving from the main entrance around the bermed area in a clockwise direction. During the drive, I noted that Coastal had installed a sign at Outfall #001, the drain on the ethanol secondary containment. The valve on this containment's drain was closed at the time of the inspection and the valve handle had been removed. There was no sheen on the water in the ethanol containment and there was approximately three inches of water standing in the containment at the spot I observed.

**Photo: 007**  
**By: Arthur Goodin**  
**Facility: Coastal Energy Corporation**  
**Permit: MO0136883**  
**Location: Howell County**  
**Description: Northeast corner of the ethanol containment marked Outfall #001.**  
**Date: 10/10/2014**  
**Program: WPC Unit**

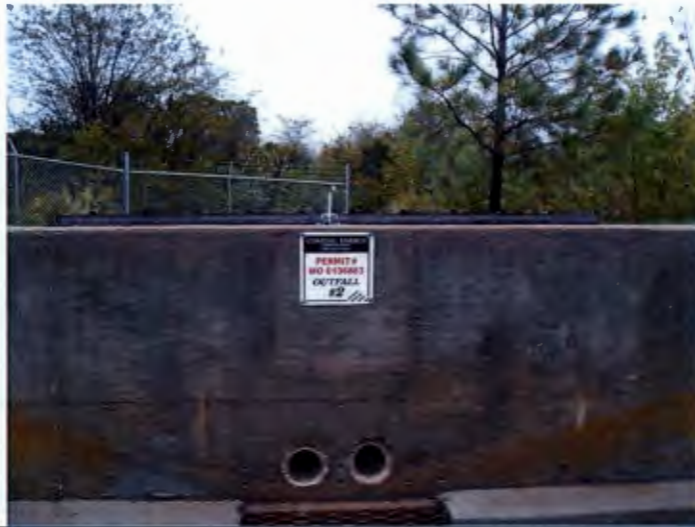
**Photo: 008**  
**By: Arthur Goodin**  
**Facility: Coastal Energy Corporation**  
**Permit: MO0136883**  
**Location: Howell County**  
**Description: Main pump station on the northeastern side of the bermed area. Marked as Outfall #002.**  
**Date: 10/10/2014**  
**Program: WPC Unit**

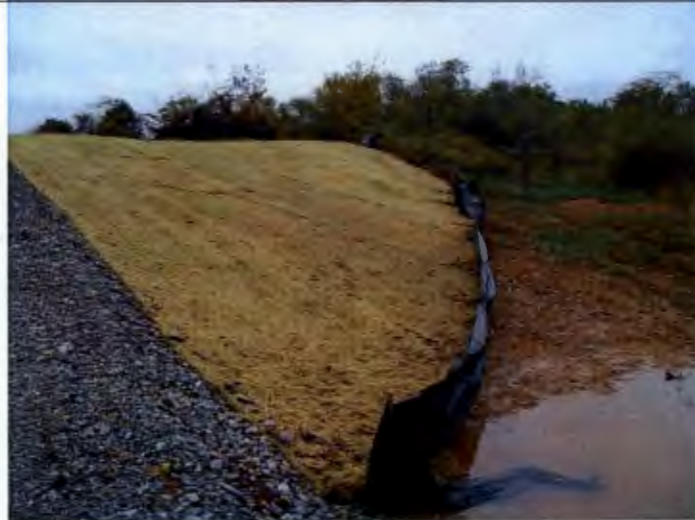
Mr. Malkowski and I then traveled to the southeast corner of the bermed area, near the end of the rail spur. At this time, I noted that stormwater was flowing over the berm in this area. During EPA's July 10, 2014 inspection of the site, it was noted that there was a pipe through the berm and a valve in this location. Mr. Malkowski informed me that the pipe and valve, along with the three other pipes through the berm, had been removed about two weeks ago. I did not see any evidence of the pipe at this point and I did observe that some earth work had been done and that silt fence had been installed near the disturbed area.

**Photo: 009**  
**By: Arthur Goodin**  
**Facility: Coastal Energy Corporation**  
**Permit: MO0136883**  
**Location: Howell County**  
**Description: Site of recent dirt work near the Eleven Point River. Photograph taken at the water's edge of the low water crossing, looking uphill to the northwest.**  
**Date: 10/10/2014**  
**Program: WPC Unit**

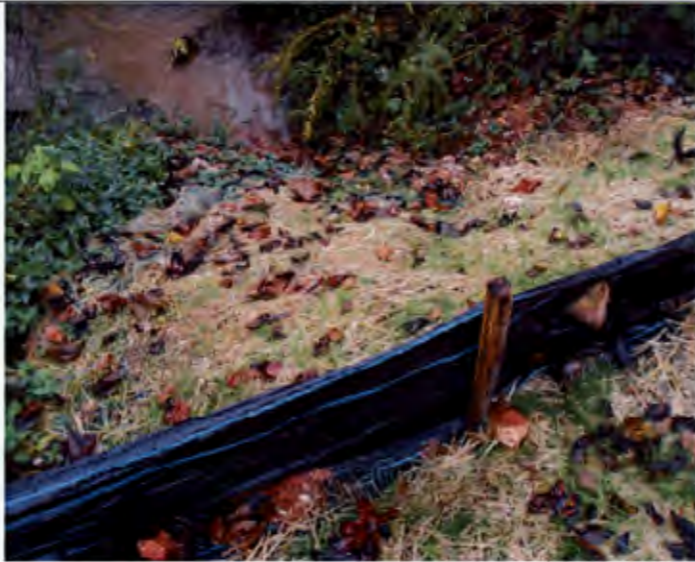
**Photo:** 010

We then crossed the rail spur and continued to the small bridge over the tributary to the Eleven point that runs along the southwest side of the bermed area. Stormwater was flowing over the berm at this point as well. Stormwater was also flowing over the bridge, but Coastal had constructed a small gravel berm at this point that was directing stormwater into the adjacent land application area. As Mr. Malkowski and I continued along the berm, I noted that the three pipes that were noted in the berm during EPA's July inspection of the site had been removed. Each of the areas where the pipes were removed were stabilized and had silt fence installed downstream of the disturbed area.

**Description:** Photograph of one of the locations where a discharge pipe had been removed from the earthen berm at the southern edge of the facility. Note the sediment and erosion controls. Also note the color of the receiving stream.

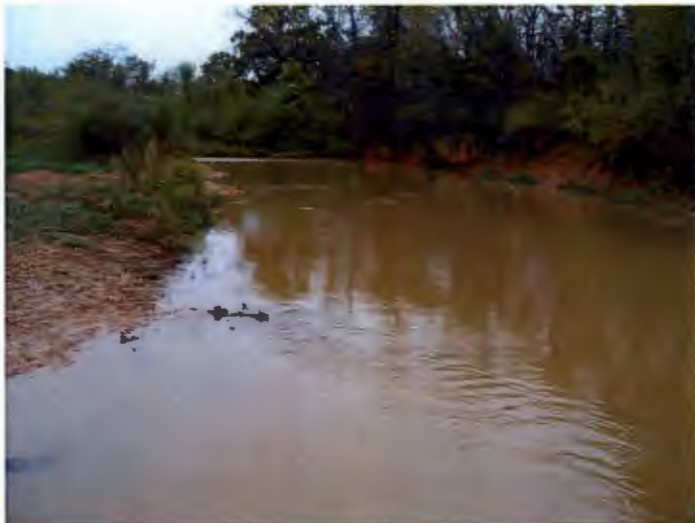
**Photo:** 011

After the closing meeting, and with the permission of Mr. Malkowski, I drove across the bridge across the tributary to the Eleven Point River on the southwestern edge of the facility's berm and continued along a gravel road on Coastal property to low water crossing that was observed during EPA's July 2014 inspection. I noted that some earth work had been done around the low water crossing and that erosion control blankets and silt fence were installed in this area. This was also my first opportunity to observe the facility's receiving stream, which is not readily visible within the bermed area due to vegetation. The Eleven Point River at the time of my inspection was several feet deep in what is a dry stream during periods when it is not raining.

The water in the stream was brown in color. I did not note any sheen or odor characteristic of petroleum.

**Description:** View looking upstream on the Eleven Point River at the low water crossing.

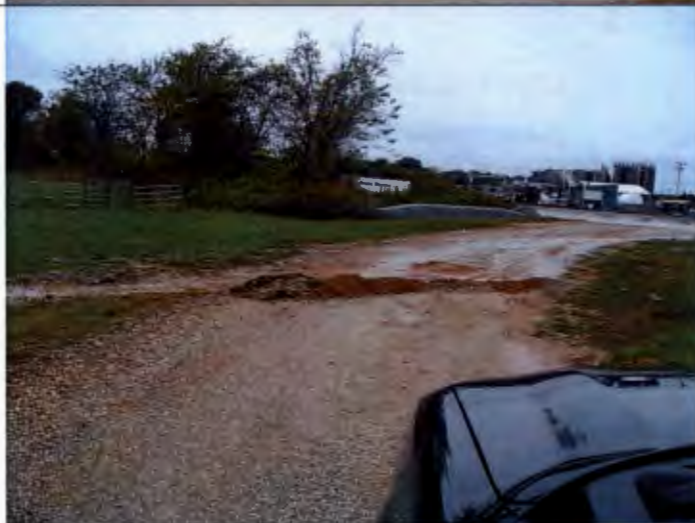
**Photo:** 012

**Description:** Temporary gravel berm constructed by Coastal on 10/9 to divert water flowing over the earthen berm.
